# Manhole Inspection Summary

Manhole # S31SS\_012MH

Insp Date: **5/2/07 9:47 AM**

**Location** Address: **2740 HUNTINGDON AVE**

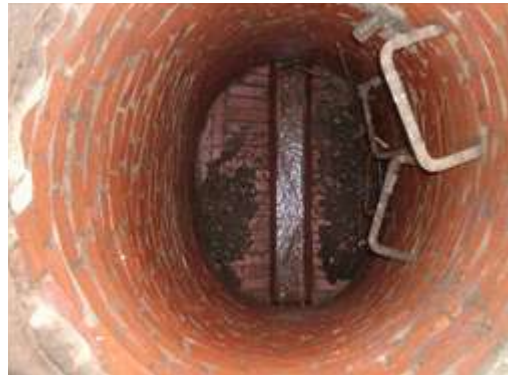
Top View

Corroded steps. Evidence of surcharge - Bench debris.

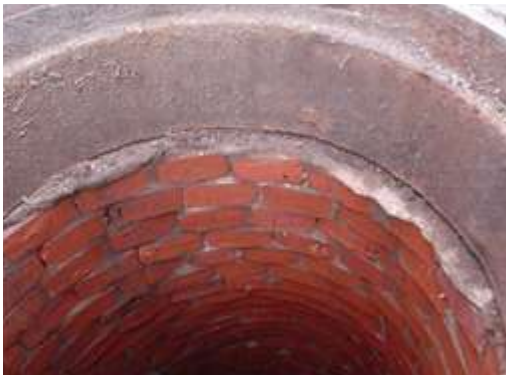
Defect

Frame leaks. Adjustment deterioration - other side.

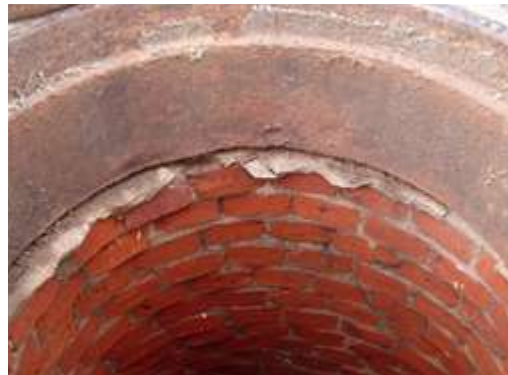
Defect

Frame leaks. Adjustment deterioration and infiltration.

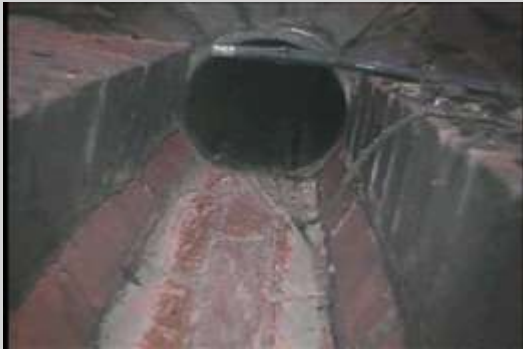
### 8 in. Circular Gravity Sewer Pipe Out @ 12 O'Clock

Invert Depth: **9.20** (ft.) Flow Characteristics: **Fast**

Infiltration: **None** Pipe Seal Cond: **Unknown**

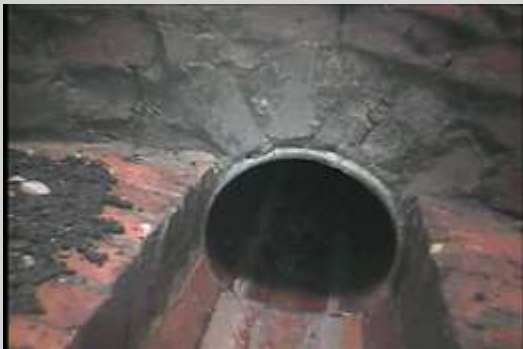
### 8 in. Circular Gravity Sewer Pipe In @ 6 O'Clock

Invert Depth: **9.15** (ft.) Flow Characteristics: **Fast**

Infiltration: **None** Pipe Seal Cond: **Unknown**
